THE JOURNAL OF INDOONESIAN ORTHOPAEDIC & TRAUMATOLOGY

Case Report

Open Reduction and Internal Fixation with Tension-Band Wiring and Cerclage for 8 Years Neglected Patellar Fracture: A Case Report

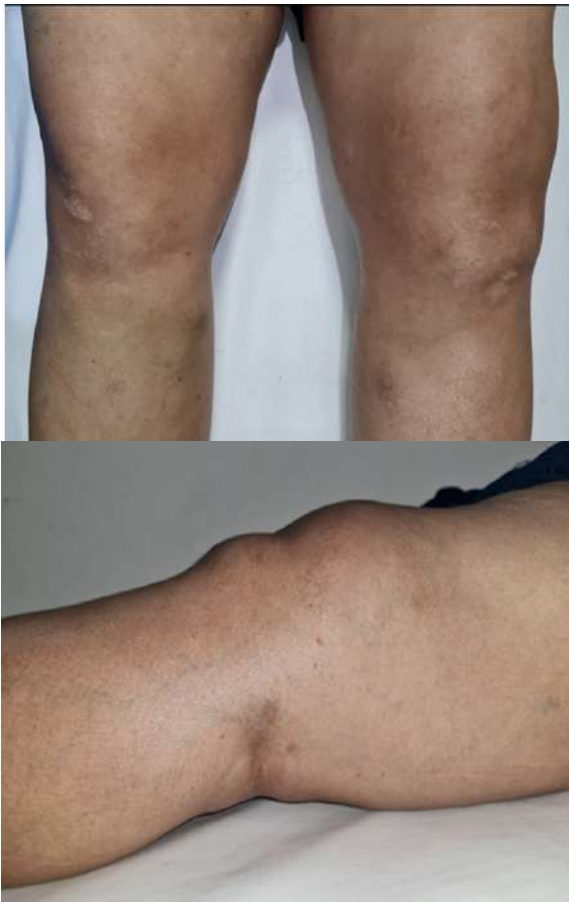
Figure 1. Clinical picture of the left knee with an obvious patellar gap

better after getting traditional massages for more than 10 times. Ever since, she got a difficulty to extend her knee but could still walk properly without any walking aid. Eight years after the accident she decided to seek medical treatment for her complaint. From pre-operative physical examination, patellar gap at the left knee was obviously seen. Neither sign of acute inflammation nor any deformity was seen. When palpated, no tenderness was noted, however, the superior pole of the patella was mobile and inferior pole was fixed (Figure 1). The patient was able to walk normally without any walking aid. She could extend her knee to 0° and flex her knee to 120°. There was no pain during flexing and extending the knee but weakness of the extensor mechanism of the left knee was observed.

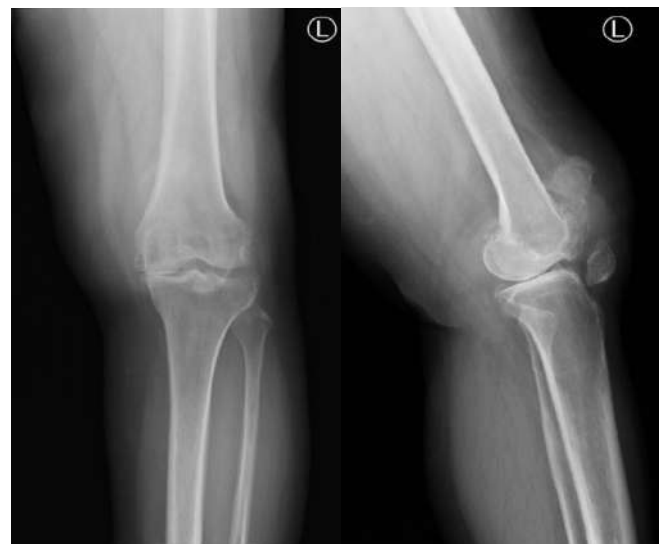
Figure 2. Left knee radiograph showing complete fracture of the left patellar bone with displacement, some visible callus around it, with fusion of the superior patellar fragment with the epimetaphysis of the right femur with soft tissue swelling around it, malunion impression left patellar subluxation anteriorly and OA grade III (according to the classification of Kellgren and Lawrence)

Radiograph was taken, revealing complete fracture of the left patellar bone with displacement, accompanied with some visible callus around it, with fusion of the superior patellar fragment with the epimetaphysis of the right femur with soft tissue swelling around it, malunion impression left patellar subluxation anteriorly and also OA grade III according to the classification of Kellgren and Lawrence (Figure 2). All these findings supported the diagnosis of neglected closed fracture left patella. Open reduction and internal fixation by using tension band wire and cerclage technique was planned and the patient agreed to surgery.

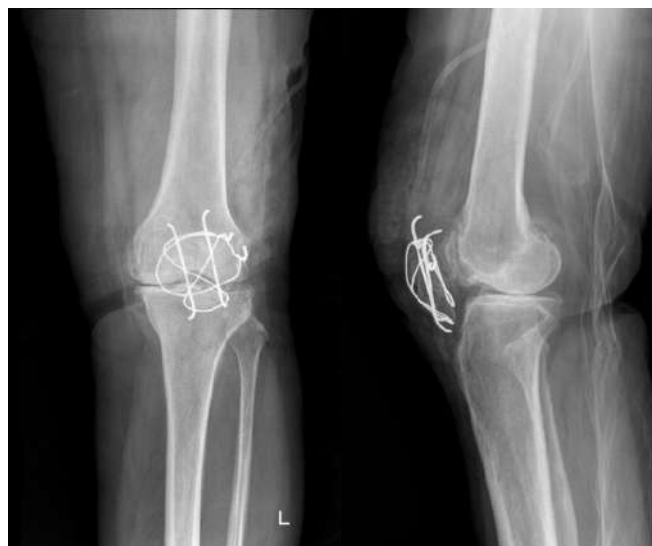
Figure 3. Postoperative left knee radiograph of anteroposterior and lateral view showing the bones and the wires in good alignment

then identified. Next, osteoclasts for cleaning fracture fragments from callus for easier reduction and fixation was performed. Anatomical reduction of the patellar bone fragment was performed, subsequently continued with fixation using S-Wire 1.2mm with cerclage method, then followed by placing 2 K-Wires 1.8mm perpendicular with the fracture line with 5 cm distance between each K-Wire and followed by applying a figure-of-eight using 1.2mm S-Wire for additional compression of the fracture site (Figure 4). An acceptable alignment of the patella and implant was observed postoperatively (Figure 3).

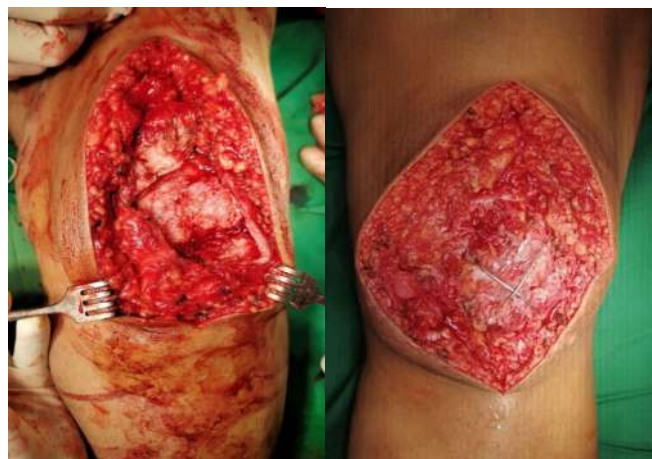
Figure 4. Intraoperative clinical picture of the left knee

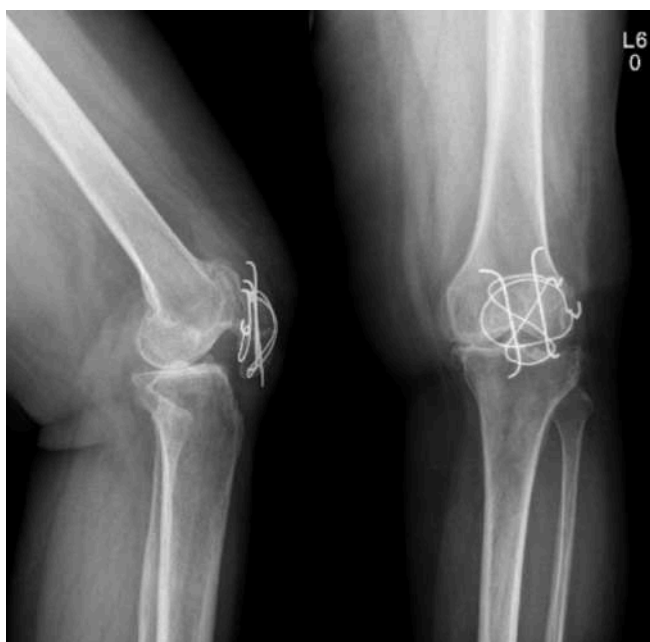
Figure 6. Postoperative left knee radiograph of anteroposterior and lateral view showing the bones and the wires in good alignment

as climbing stairs and sitting. The patient was also able to return to work with a total score of 28 points, an excellent result. Fracture line was no longer visible on a 3-months post operative radiograph (Figure 6).
